**St Clement's Aisle, Dingwall Parish Church,  
Dingwall, Highland**

**Report on Geophysical Survey  
Electrical Resistance**

October 2011

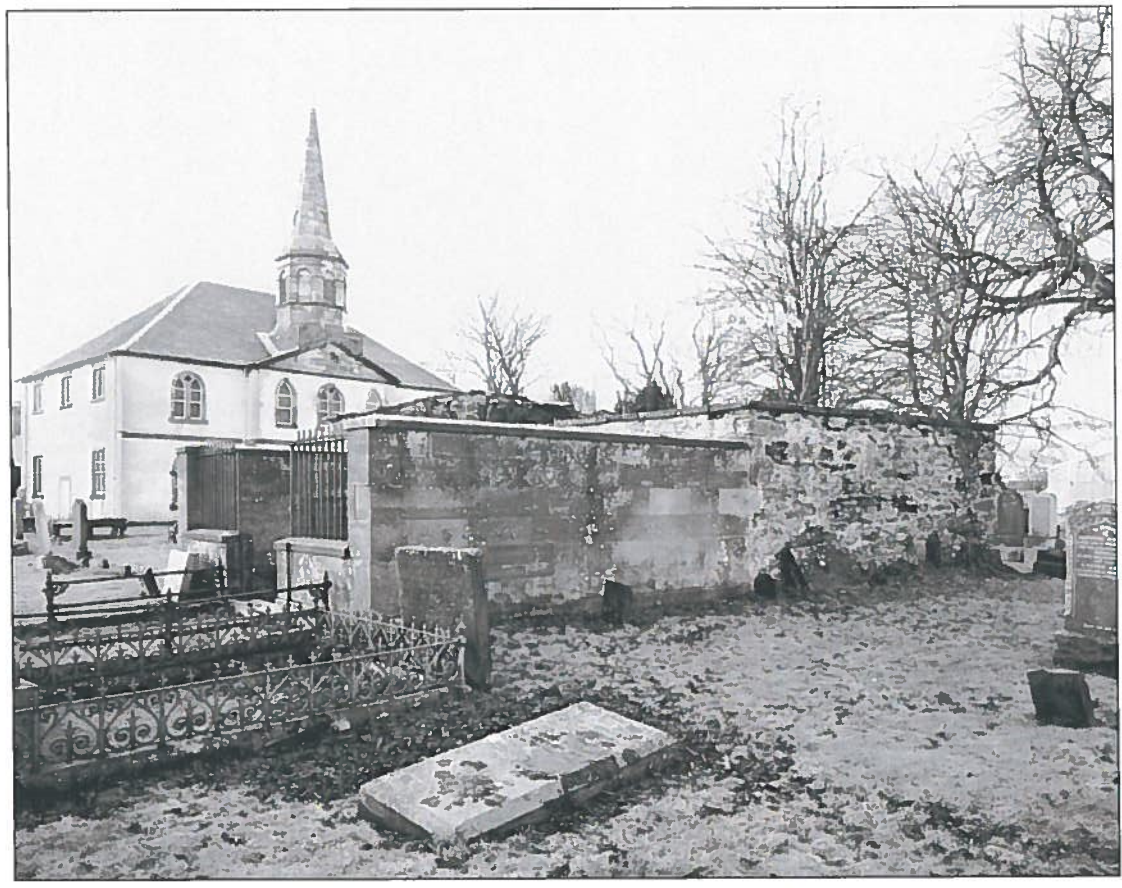
**Figure 2.** General view of St Clement's Aisle from the north-east in 1963.  
 ©Crown copyright (NMRS Item SC 917841) / Dingwall Museum Trust.

The aisle was adapted into a family mausoleum and the southern aperture blocked, most likely at the demolition of the previously adjoining church. The building measures 10.2m x 7.2m and 3.0m in height (Figure 2). Unfortunately, the southern vault has recently collapsed, obscuring internal features of a formerly roofed arched recess. The aisle is currently in a rapidly deteriorating condition and the wall core has become exposed at the south-west interior. A rectangular doorway is located in the middle of the west wall. At the base of the interior of the north wall is the low arch of further small recess, probably late-medieval in date and intended for burial. Several other structural features are evident encased in the exterior walls, such as a possible window south of the current doorway. A detailed standing building survey is likely to be productive for understanding the aisle's structural history and development.

A modern fence has been erected for safety surround the exterior circumference of the aisle, which has restricted access to a 2m buffer zone around the building. At the north-east a 19<sup>th</sup>-century burial enclosure extends approximately 4m from the outer face (Figure 2). Two adjoining burial enclosures that date to the post-medieval period are located to the south-west of the aisle. These enclosures are apparently on the site of a church tower built in the 17<sup>th</sup>-century (Figure 4). Between the aisle and the current church is a further burial enclosure, which is surrounded by a stone wall with iron railings. The surrounding churchyard contains several 19<sup>th</sup> and 18<sup>th</sup>-century gravestones. These memorials are generally laid out in rows aligned north to south. To the south-east of the aisle there are notable undulations in the turf, which may indicate *in-situ* remains of the old church's wall foundations, possibly parts of the medieval chancel.

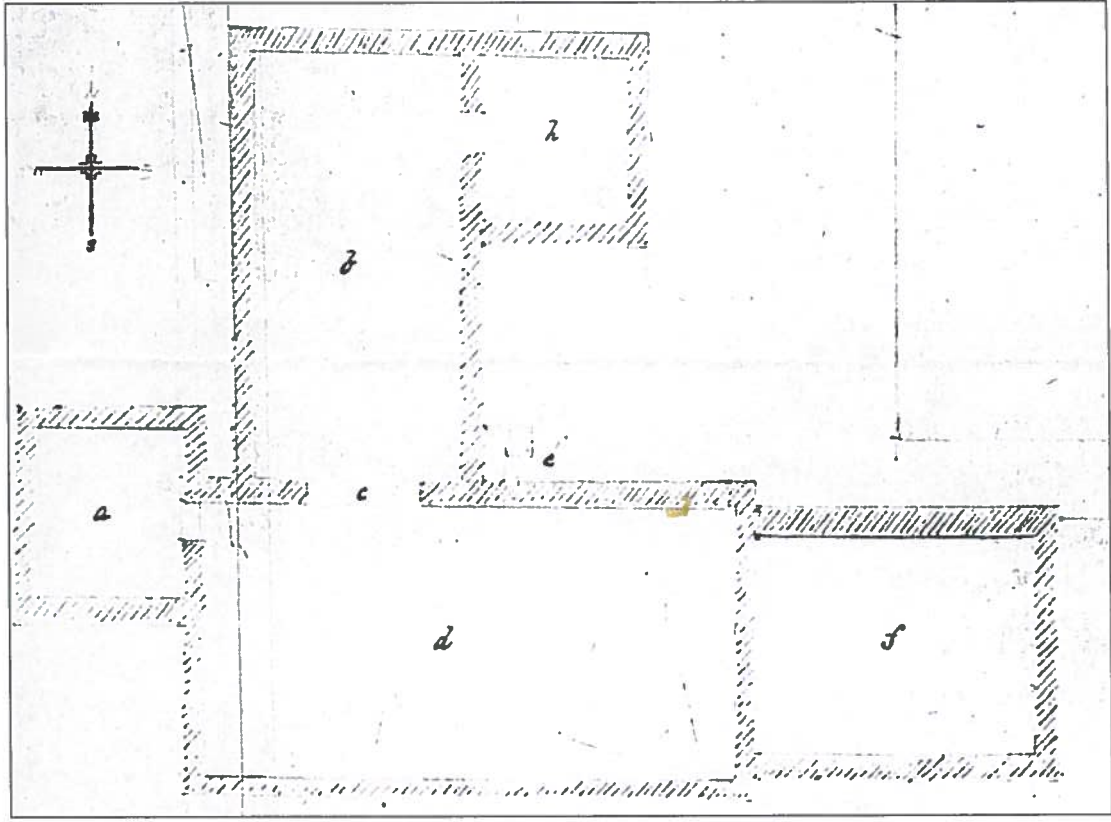
Figure 4. Plan of St Clement's Old Parish Church dating to 1849 after demolition.  
 Courtesy of Dingwall History Society.

Two plans of the old church exist, the first dating from 1776, prior to demolition, and the second, from 1849, based on retrospective accounts. The 1776 plan shows a simple nave with a small northern aisle and two doorways on the southern wall (Figure 3). The apparent lack of details on this plan, in comparison to the 1849 plan, may be because it is largely concerned with contemporary arrangements for seating within the church. Although the 1849 plan was based on retrospective accounts, it does appear to add information about the location of the square tower on the north-west corner, the Tulloch enclosure on the north-east side of the aisle, a northern external staircase and indicates an overall bicameral arrangement with a square chancel to the east (Figure 4).

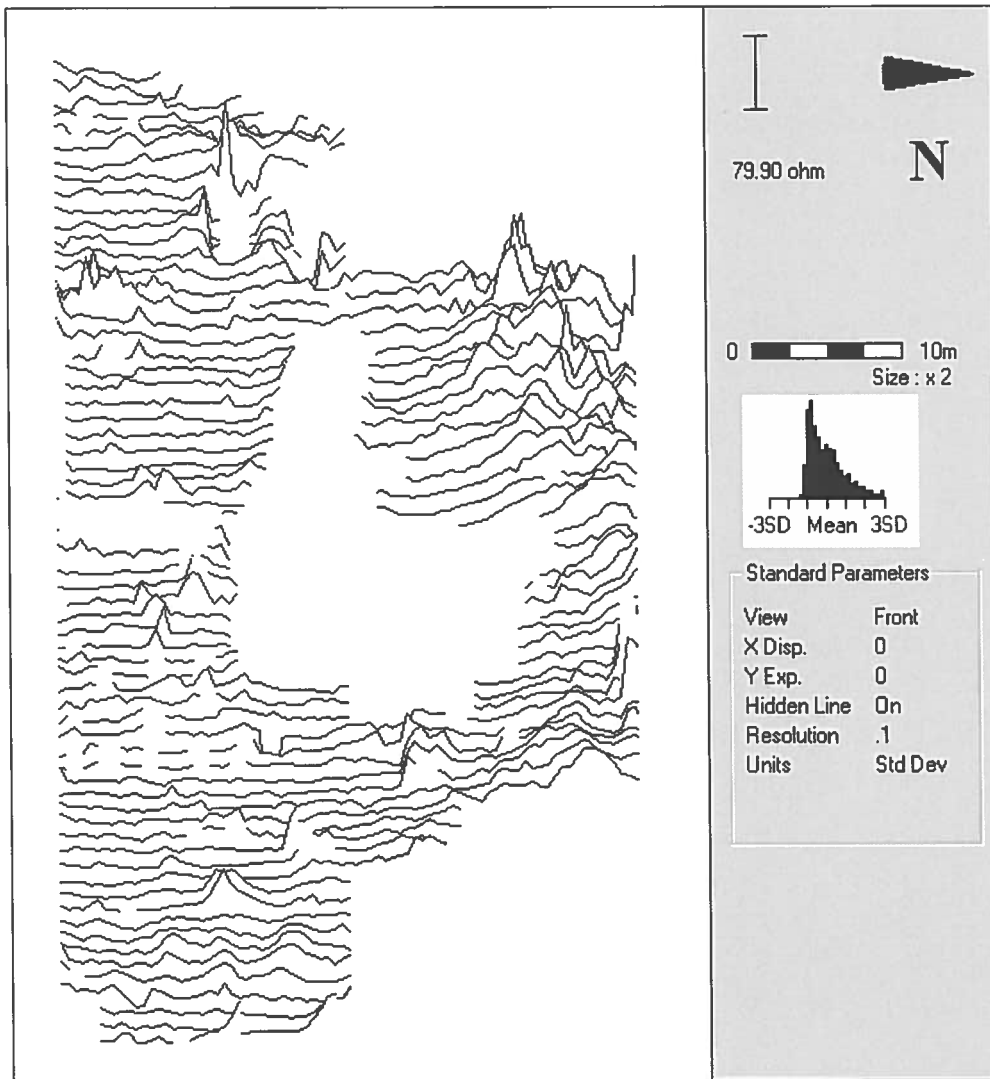
Raw resistance data (0.5m probe, trace plot).

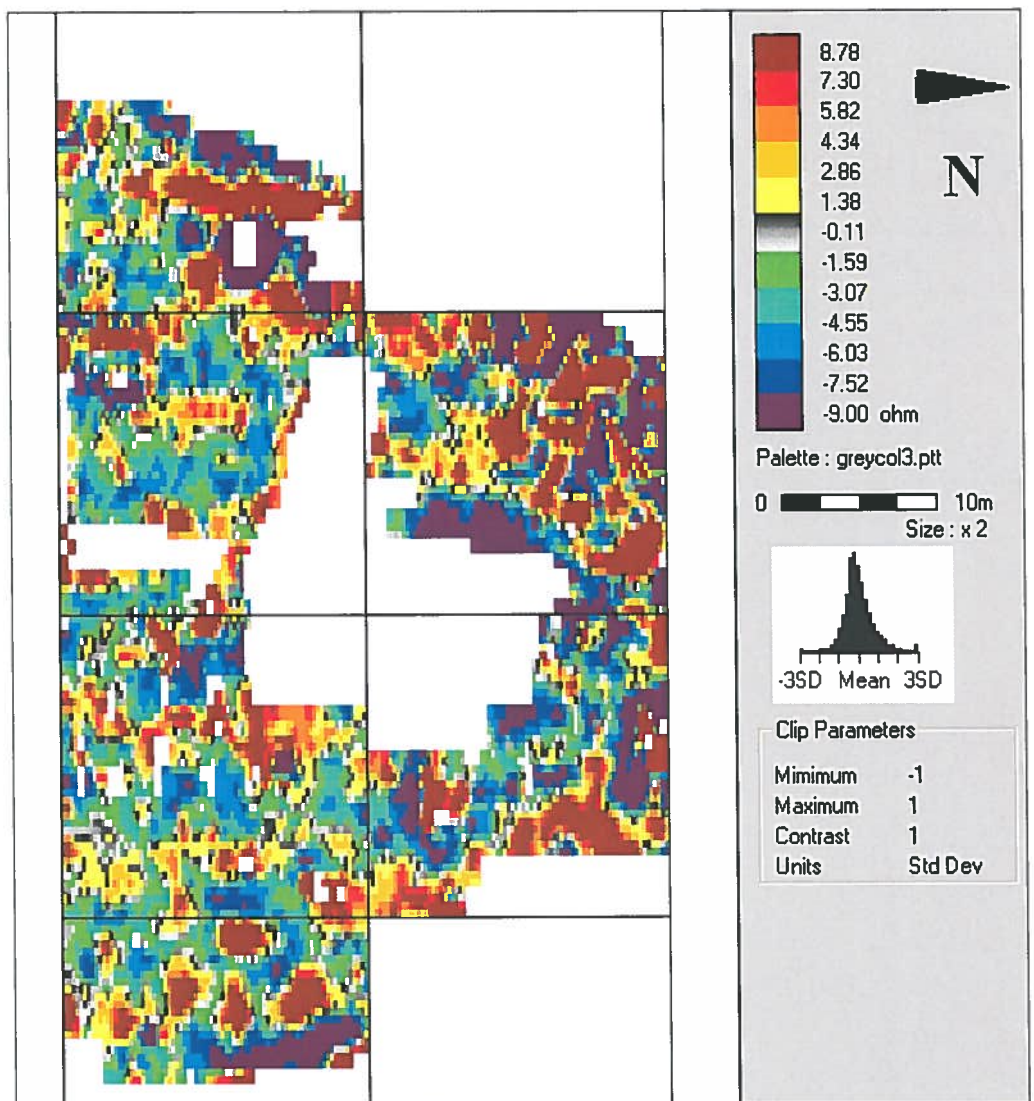
Raw resistance data (0.5m probe, colour palette).

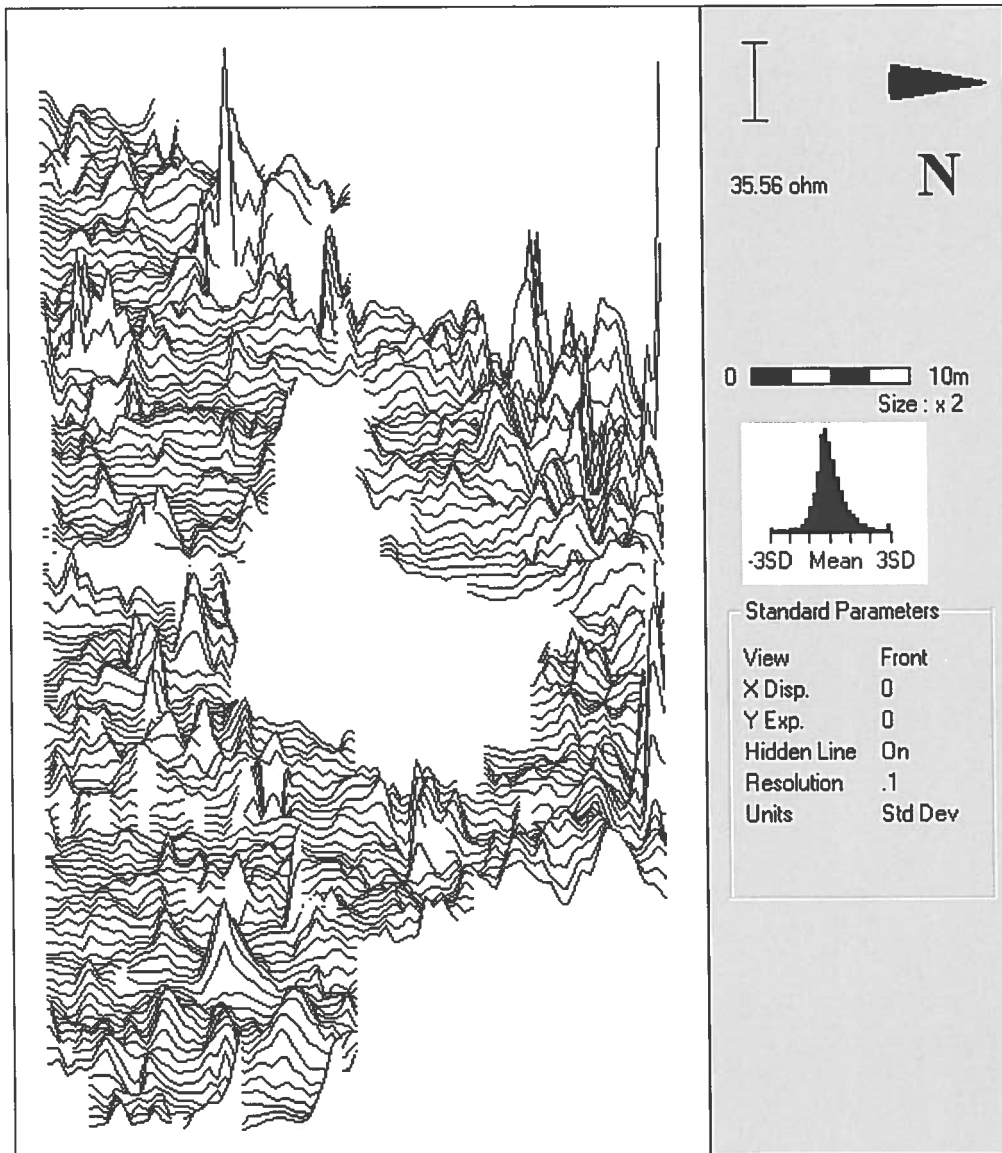
Interpolated resistance data (0.5m probe, trace plot).

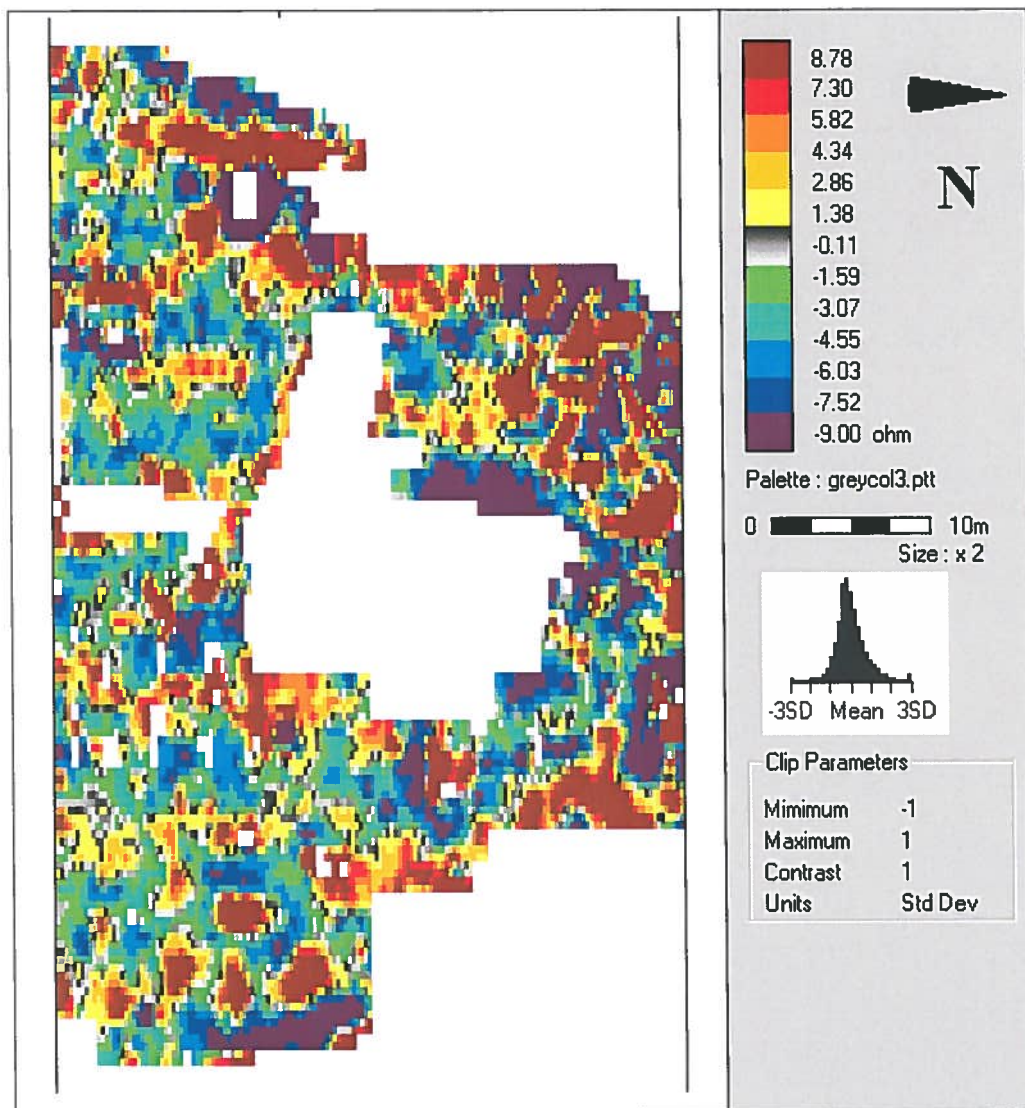
Interpolated resistance data (0.5m probe, colour palette).
